Structural Survey Report

Sample Report
Devonshire

Mason and Associates Ltd.
July 25th, 2017

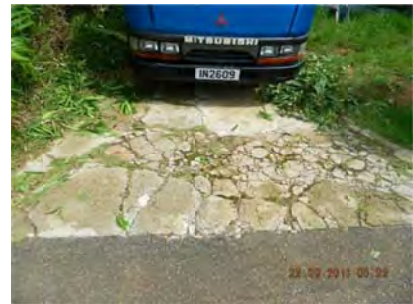
Condition: Not Satisfactory

Driveway and hard surface parking show significant cracking and deterioration and should be replaced with new concrete or asphalt, sloped to drain correctly.

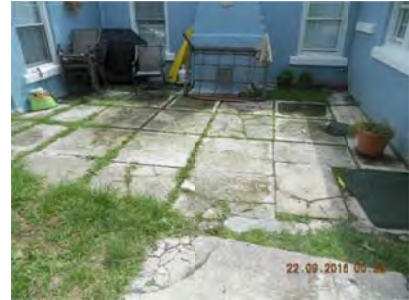
Sidewalk / Walkway

Condition: Needs Maintenance

Several crack pavers noted. Replace with new.

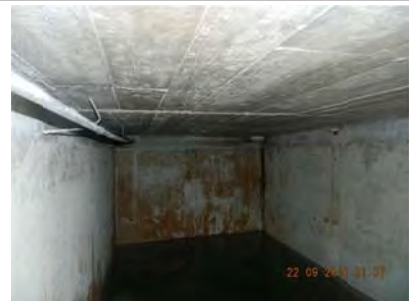
Water Tank

Condition: Needs Maintenance

Some sediment and debris noted. Clean and sanitize tank. Replace horizontal galvanized suction lines with new PVC piping supported at 4ft intervals

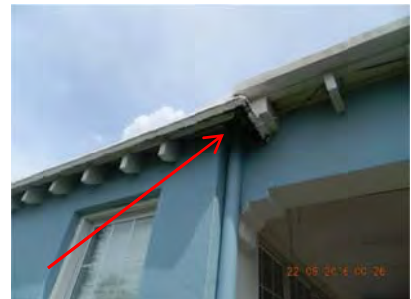
Eaves and Soffits

Some moisture damage and crack noted at porch downpipe. Repair and seal.

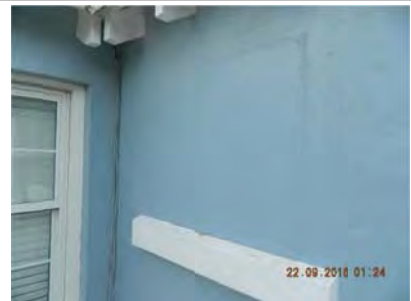
Wall Structure

Condition: Needs Maintenance

Window blocked with board material and caulked. Exterior paint appears well maintained but we did note some areas of debonded rendering (hollow) which may lead to increased moisture affecting interior wall finishes.

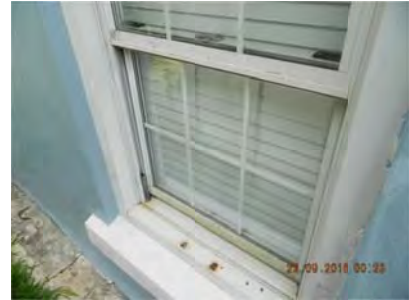
Windows

Type: Double hung
Material: Metal
Glass Properties: Dual pane.
Condition: Needs Maintenance

Several windows noted to show signs of deferred maintenance. Stiff movement and unable to securely lock. Repair or replace windows with newer PVC type. Frames appear satisfactory.

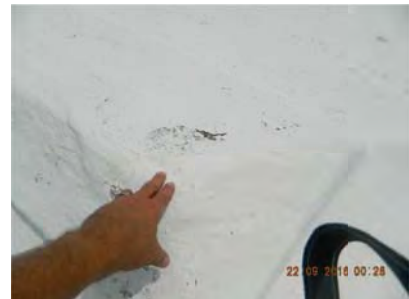
Roof Covering

Condition: Needs Maintenance

Some spalling and flaking of roof covering noted. Some hairline cracks. Repair and recoat roof.

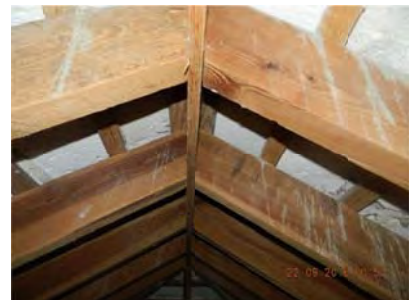
Roof Framing

Framing appeared dry and robust. Some indications of drywood termite activity but damage to framing is limited and not a structural concern at this time. We would recommend tent fumigation for termite treatment.

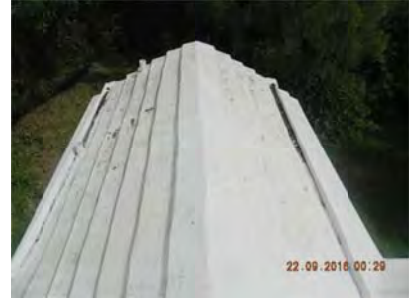
Gutter Glides and Downspouts

Condition: Needs Maintenance

Discoloration indicates debris buildup and water ponding. End gable wall with exposed 2" RWP needs rethinking.

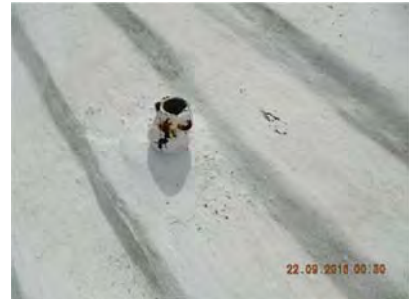
Roof Vents / Protrusions

Corroded cast iron bathroom vent should be replaced with PVC and sealed at slate level.

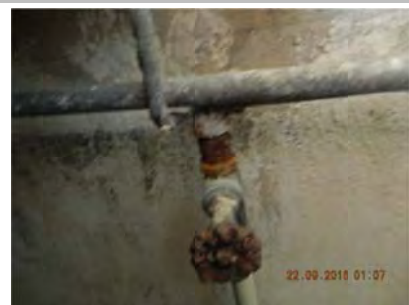
Water Entrance

Condition: Needs Maintenance

System appears functional but aging galvanized piping and valves show some corrosion and deterioration. We recommend replacing all galvanized pressure pipe and fittings with new PVC.

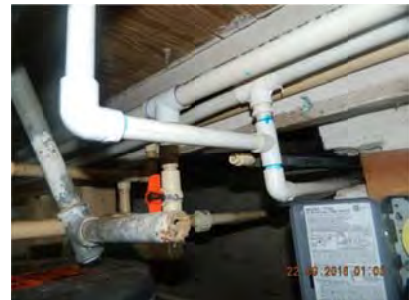
Pipes

Material: PVC and galvanized mix
Flow rate: Satisfactory
Condition: Needs Maintenance

Some evidence of pipe replacement with PVC noted. Remainder of piping should be replaced with new.

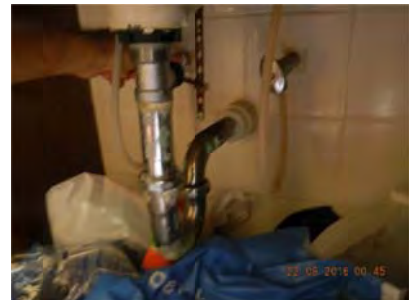
Fixtures

Functional but Ptraps and valves show some deterioration.

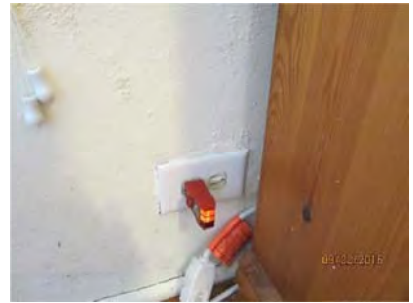
4.38 Receptacle's tab has rusted out, device needs replacing.

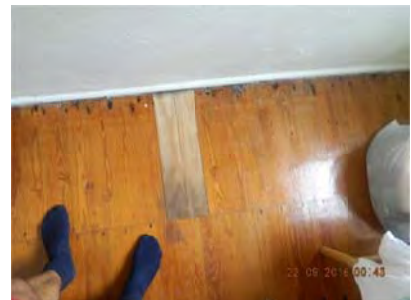
Condition: Needs Maintenance

Some repair patches noted. Floors should be sanded to match. Tiled flooring appears satisfactory.

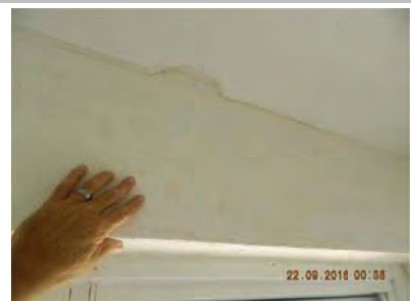
Walls

Condition: Needs Maintenance

Some efflorescence and moisture damage noted at the dining room beam and walls near windows. This coincides with the exterior RWP and earlier comment to repair.

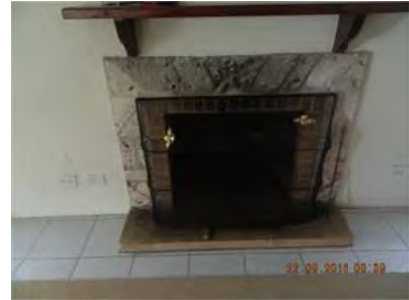
Fireplace

Type: Wood-burning
Operational: Yes
Condition: Needs Maintenance

Some smoke/soot staining to exterior firebox finishes. Flue should be inspected and cleaned by a certified chimney sweep. Draw should be tested.

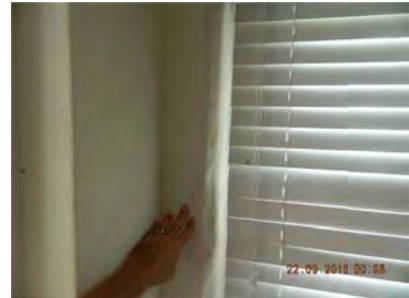
Moisture and Mildew

Degree of Damage: Some condensation
Condition: Needs Maintenance

Dining room walls show some paint finish deterioration. Debonded exterior plaster may need to be hacked off back to base masonry and replaced with a Xypex infused plaster finish, primed and painted after correct curing.

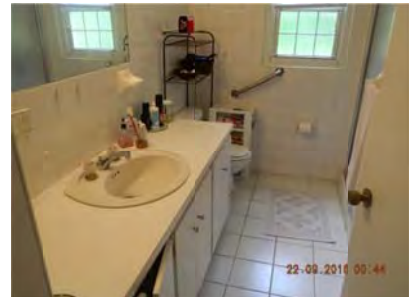
Bathroom is functional. Repairs needed to toilet flapper and fill valves. Shower door frame noted to be loose.

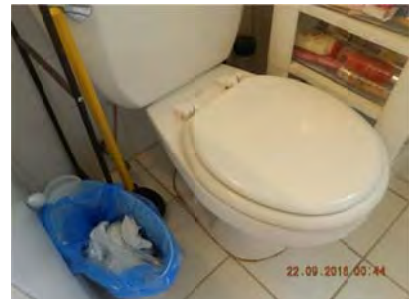
Toilet

Condition: Needs Maintenance

Flushed tested OK. Flapper and fill valve need adjusting or replace with new.

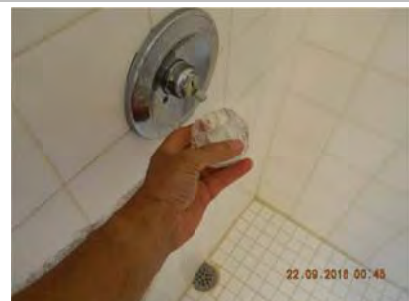
Condition: Needs Maintenance

Faucet lever needs repair. Grout lines show some discoloration and age.

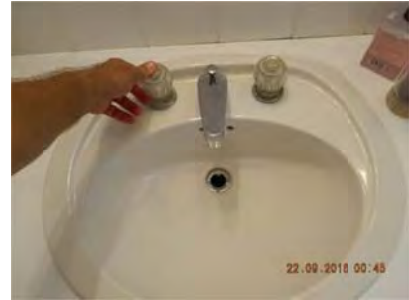
Bathroom Sink

Condition: Needs Maintenance

Left (HW) valve not operational. Drain stopper is missing.

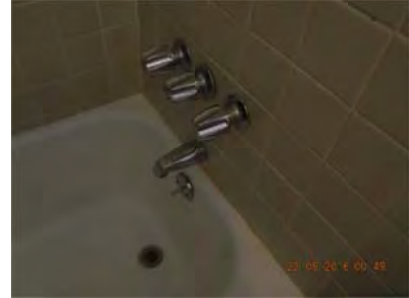
Condition: Needs Maintenance

Faucets and spout show significant pitting. Tub is functional

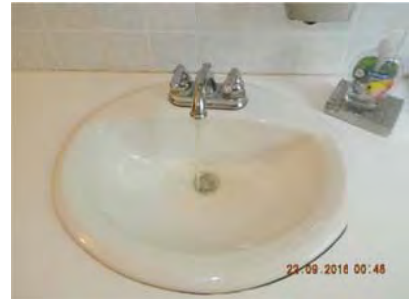
Bathroom Sink

Condition: Needs Maintenance

Sink is functional but shows some mold staining at rim.

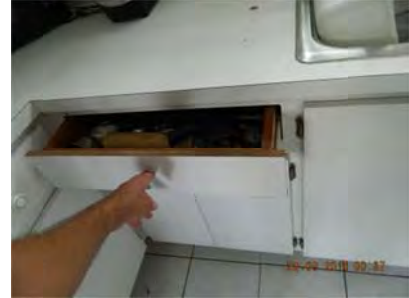
Condition: Needs Maintenance

Some edge stripping missing. Cabinets and drawers are functional but as a whole show some obsolescence and would benefit from upgrading to new.

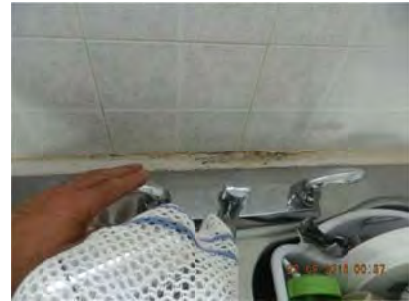
Countertop

Condition: Needs Maintenance

Backsplash area at counter level shows some deterioration.

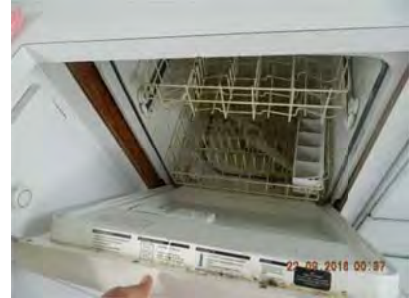
Type: Not inspected
Make: Kenmore
Condition: Needs Maintenance

Appliance appears to be loose and needs to be correctly positioned within cabinets. Dishwasher appears aged and may benefit from replacement with new.

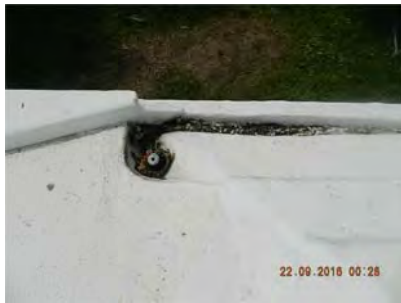
Roof shows some flaking and spalling. Some debris accumulation in gutter glides.

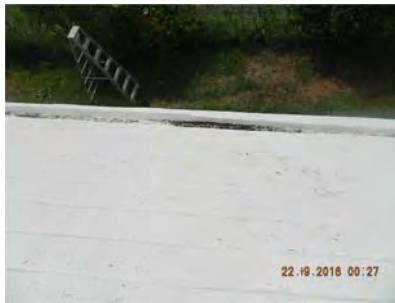
Debris at downspouts. Clean and maintain

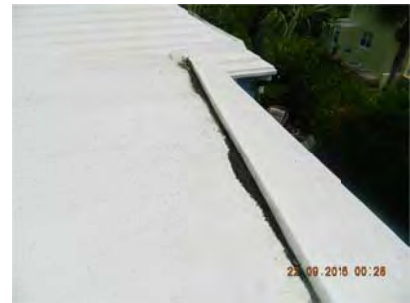
Water ponding at mold staining

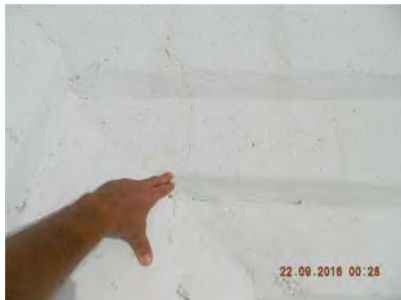
Porch roof gutter glide, water ponding

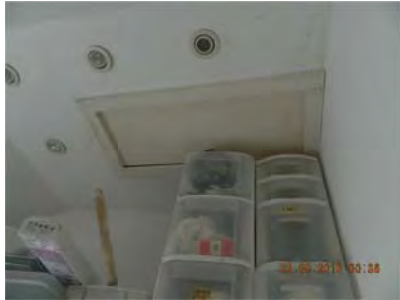
Minor moisture staining

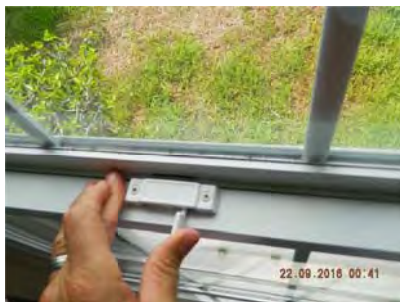
Several window latches need adjustment/repair

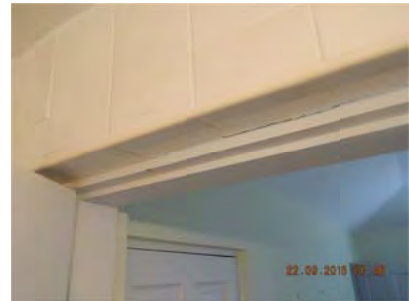
Shower door frame is loose
