Structural Survey Report

Sample Report
Devonshire

Mason and Associates Ltd.
July 25th, 2017

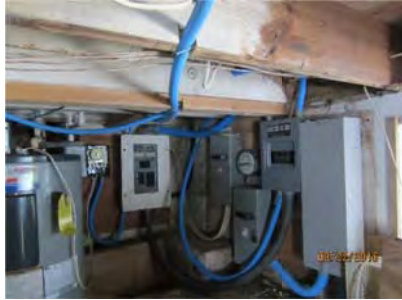
1.1 A Single 100A 120/240V single-phase metered service located within the basement east side of dwelling. Appears general sound.

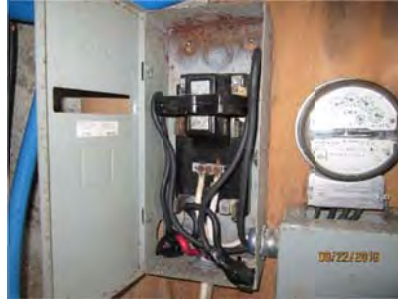
1.2 Disconnect not in use as a switch but now used as a junction box.

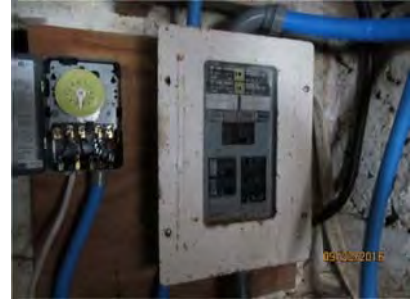
2.1 A 12-CCT 120/240V Main distribution panel is located in the basement. The panel directory needs to be filled.

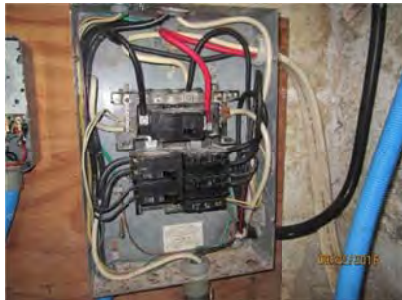
2.2 Circuit breakers, conductors and feeder appear generally sound.

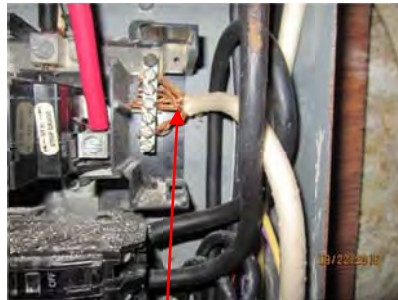
2.3 The neutral conductor must terminate on a single lug. Lug needs to be installed.

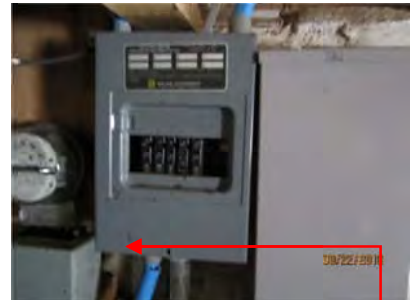
3.1 A 8-CCT 120/240V Sub panel located in the basement. Appears generally sound. Screw for cover needs to be installed.

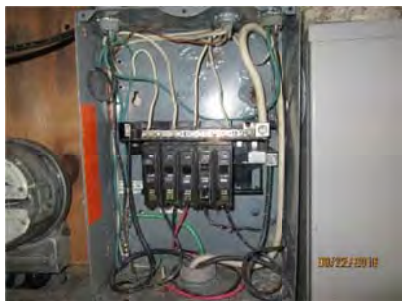
3.2 Circuit breakers, conductors and feeder appear generally sound.

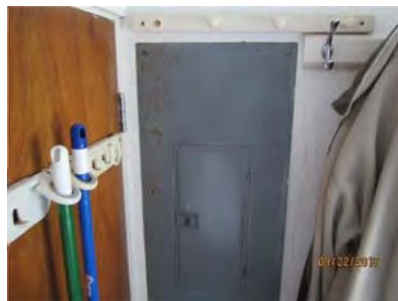
3.3 A 30-CCT 120/240V Sub panel located in the laundry. Appears generally sound.

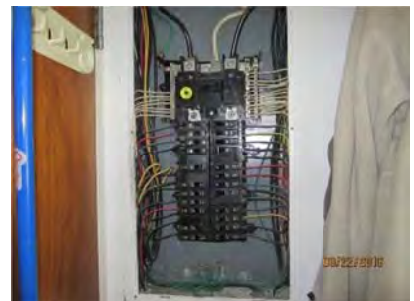
3.4 Circuit breakers, conductors and feeder appear generally sound. 220V Circuits 9/11 have been disconnected

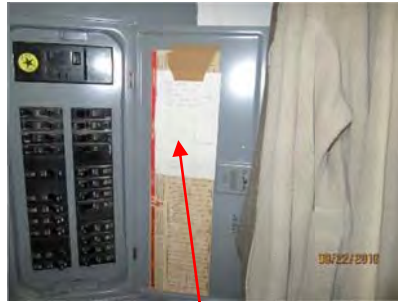
3.6 The panel directory needs to be completed.

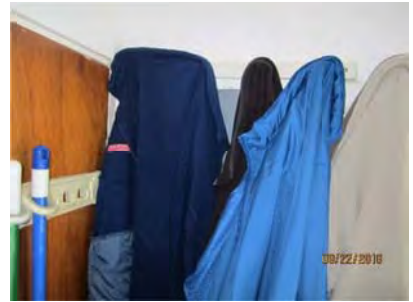
3.7 Panel located behind these jackets.

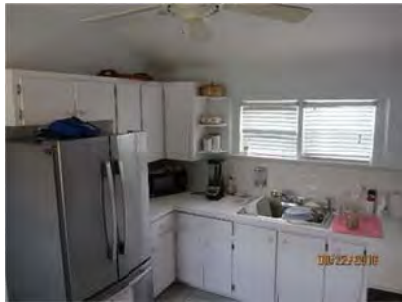
4.1 Kitchen fixtures and switches, outlets appeared sound.

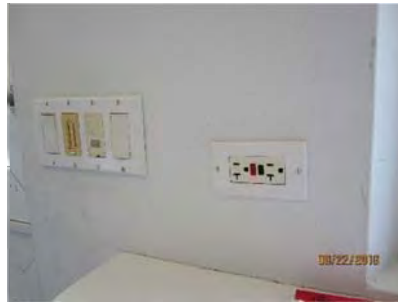
4.2 GFCI east wall tested ok.

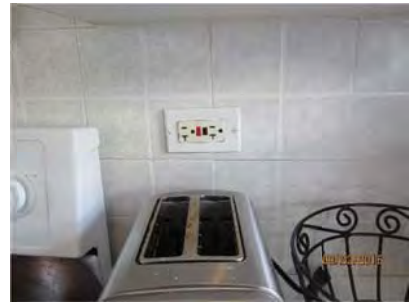
4.3 GFCI north wall tested ok.

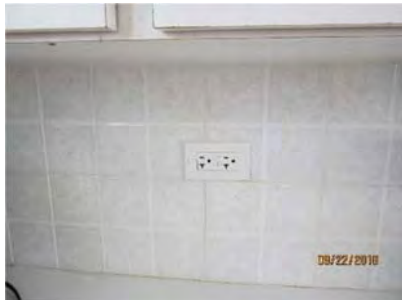
4.4 GFCI north wall tested ok.

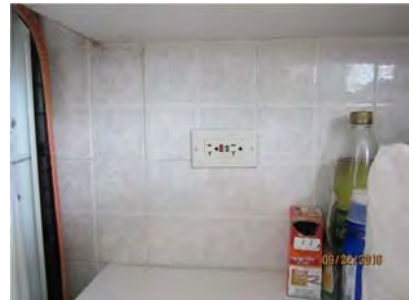
4.6 GFCI south wall tested ok.

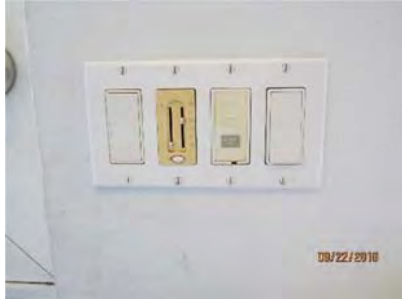
4.7 Switches appeared generally sound

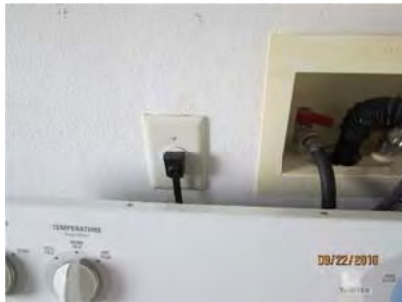
4.10 Washer and receptacle outlet appeared generally sound.

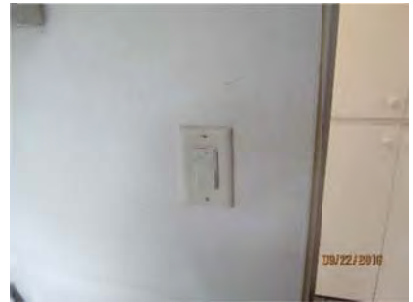
4.12 Switch for laundry room lights appeared generally sound.

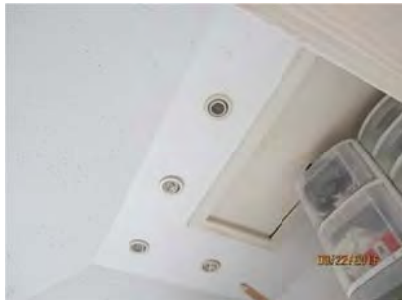
4.13 The ceilings lights in the laundry did not function. Likely bulbs need changing.

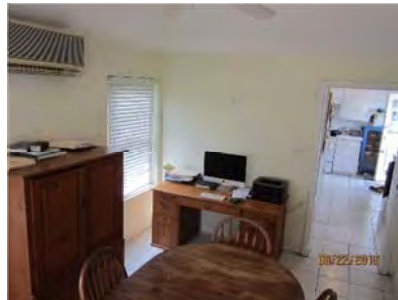
4.14 Dining room fixtures switches and outlets appeared generally sound.

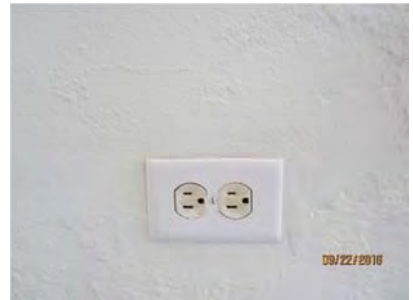
1.15 Receptacle outlet appeared generally sound.

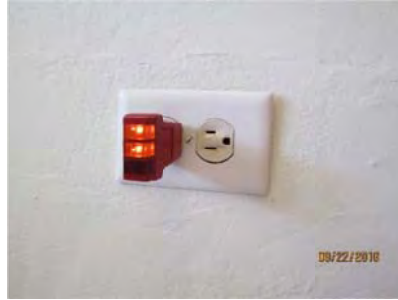
4.17 Receptacle outlet appeared generally sound.

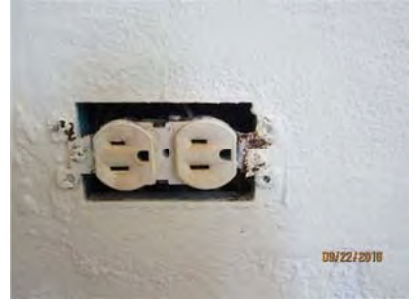
4.18 Receptacle outlet appeared generally sound.

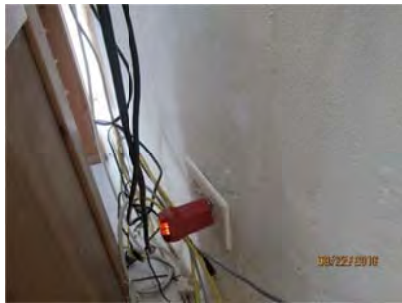
4.19 Receptacle outlet appeared generally sound.

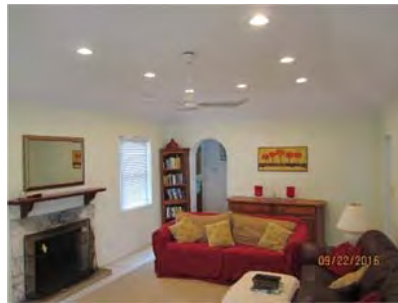
4.20 Living Room fixtures switches and outlets appeared generally sound.

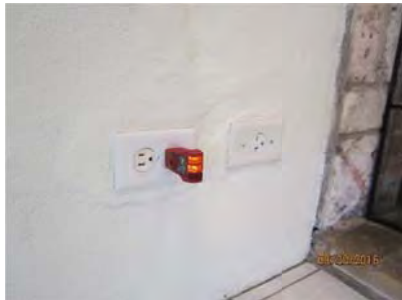
4.22 Receptacle outlet appeared generally sound.

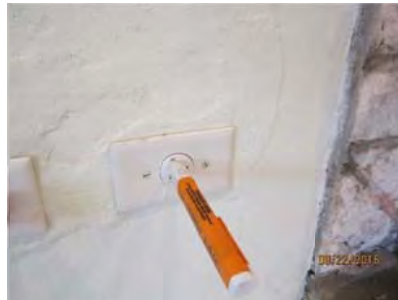
4.23 220V Receptacle here had no power. North wall area.

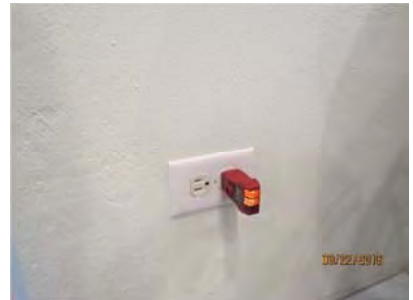
4.24 Receptacle outlet appeared generally sound

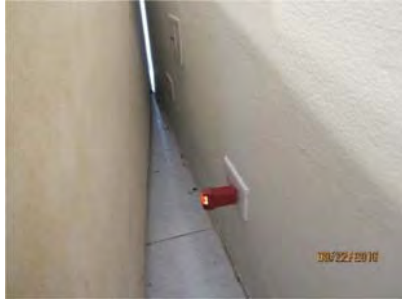
4.25 Receptacle outlet appeared generally sound.

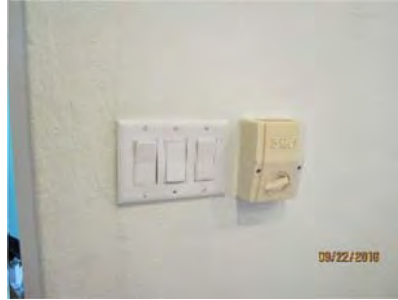
4.26 Switches appeared generally sound.

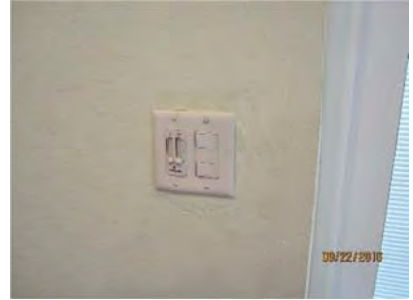
1.27 Switches appeared generally sound.

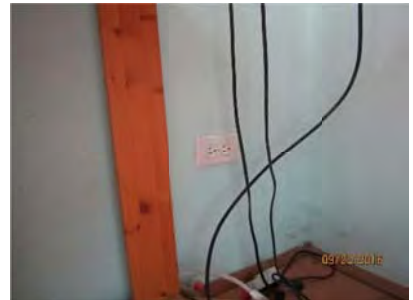
4.30 Receptacle outlet appeared generally sound.

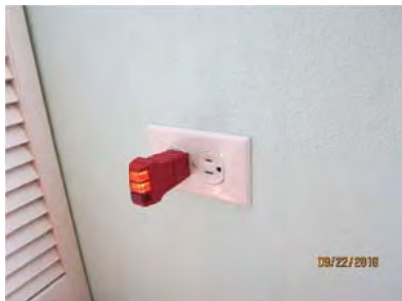
4.31 Receptacle outlet appeared generally sound.

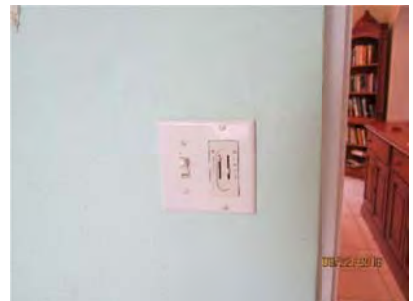
4.33 Switches appeared generally sound.

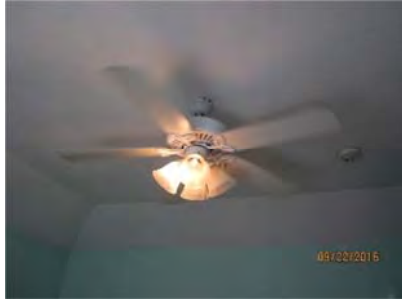
4.34 Ceiling fan and light appeared generally sound.

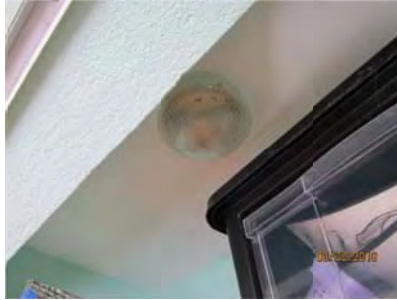
4.35 Closet fixture appeared generally sound.

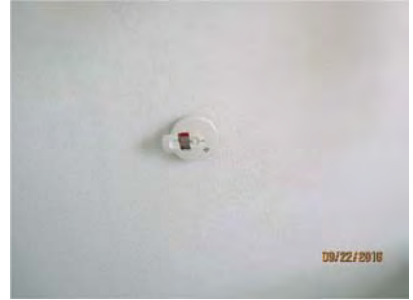
4.36 Smoke detector appeared generally sound.

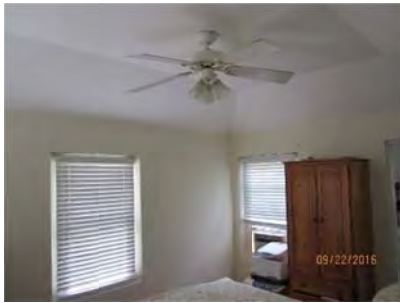
4.37 Master Bedroom fixtures, switches and outlets, smoke detector appeared generally sound.

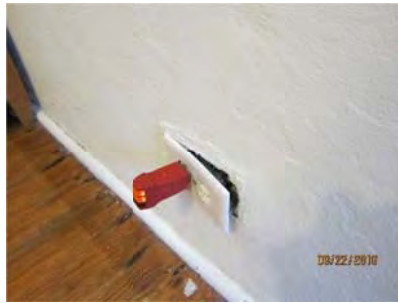
4.38 Receptacle's tab has rusted out, device needs replacing.

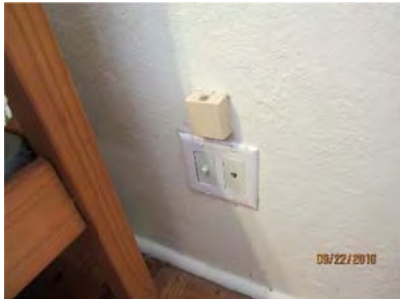
4.40 Receptacle outlet appeared generally sound.

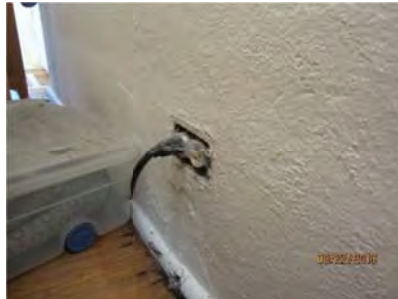
4.41 Receptacle outlet appeared generally sound but a cover plate is needed.

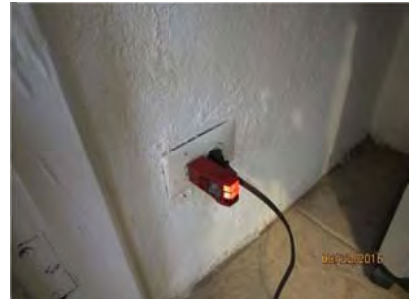
4.42 Closet receptacle outlet appeared generally sound.

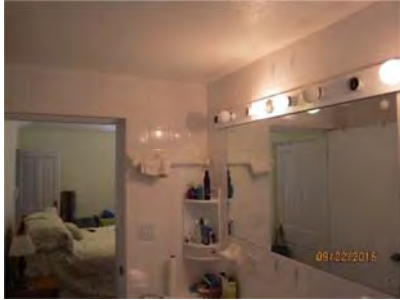
4.43 Master Bedroom fixtures switches and outlets appeared generally sound

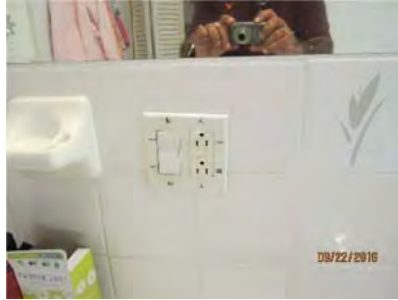
4.44 GFCI Receptacle outlet tested ok. Appeared generally sound.

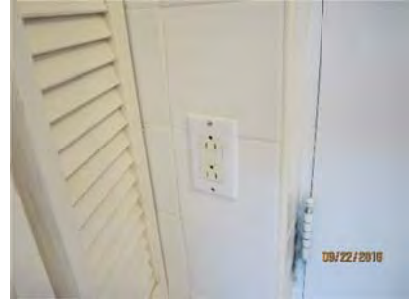
4.45 GFCI Receptacle outlet tested ok. Appeared generally sound.

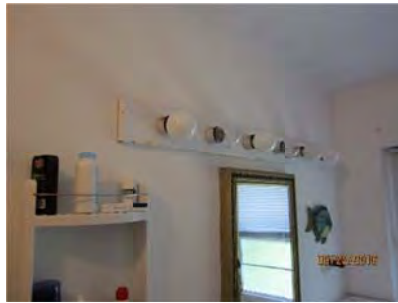
4.47 Hallway Bathroom fixtures switches and outlets appeared generally sound.

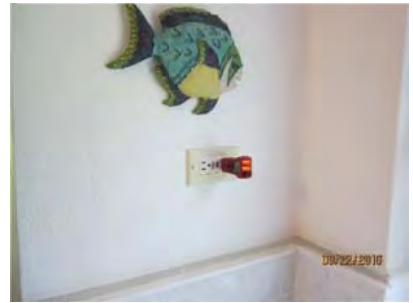
4.48 GFCI tested outlet ok. Appeared generally sound.

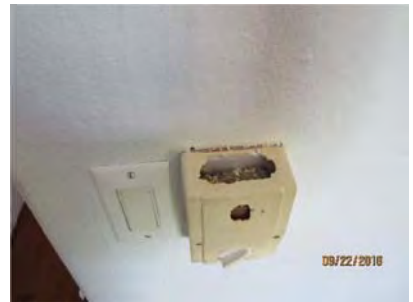
4.50 East Bedroom fixtures, switches and outlets appeared generally sound

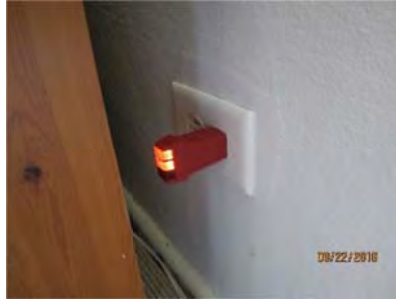
4.52 Receptacles outlet appeared generally sound.

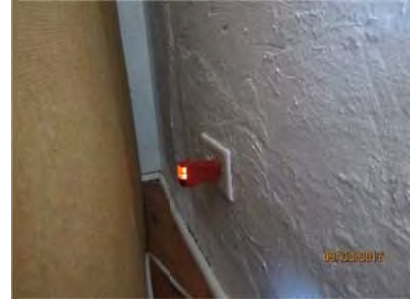
4.53 Receptacle outlet appeared generally sound.

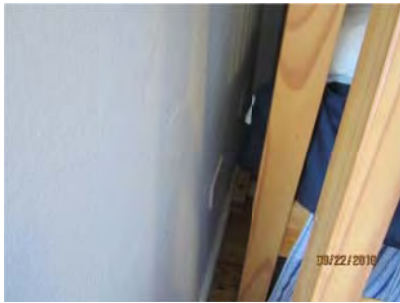
4.54 Receptacle outlet appeared generally sound.

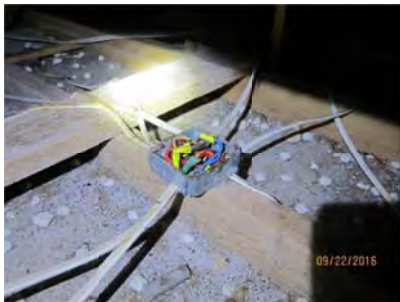
4.57 Roof Space NM cable, mostly the wiring method of choice, appears generally sound.

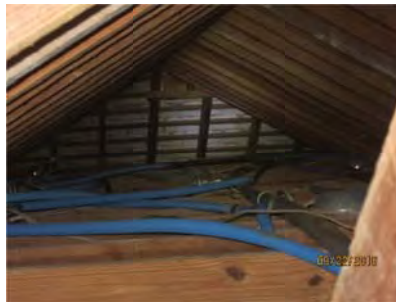
4.58 A blank plate is needed for the J box (east bedroom closet access).

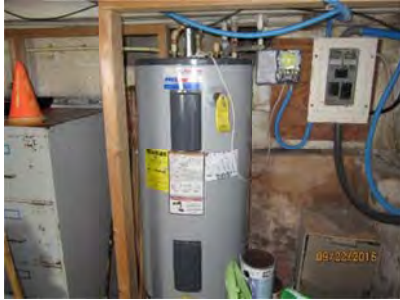
5.1 Pump/Utility room/Water heater located in the basement. Fixtures switches and outlets appeared generally sound.

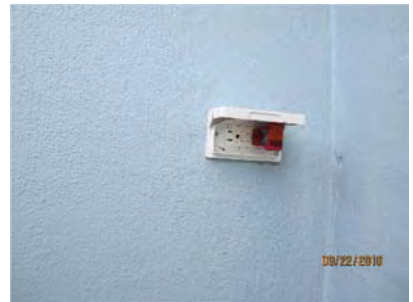
6.5 Receptacle outlet located on the south porch needs a GFCI receptacle installed to protect personnel from electrical shocks.

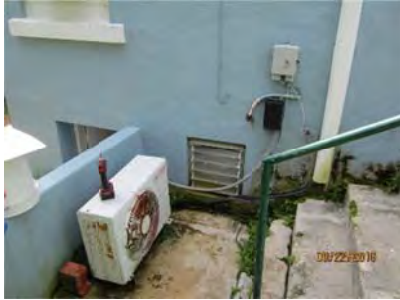
6.6 GFCI receptacle located east side of dwelling tested ok. Appeared generally sound.

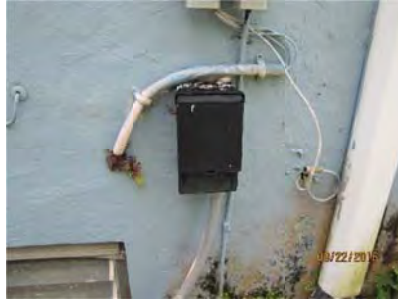
6.7 A Split system condensing unit located on the east side of dwelling is not functional.

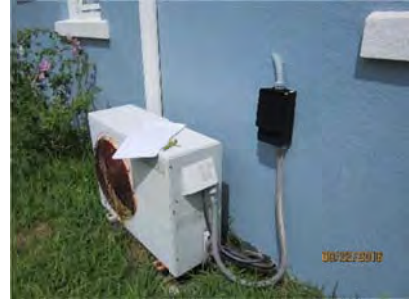
6.8 Disconnects for the condensing units were disconnected.

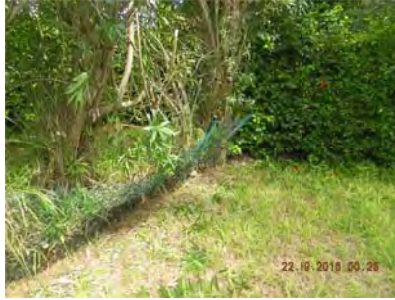
Chain-link fencing/posts need repair.

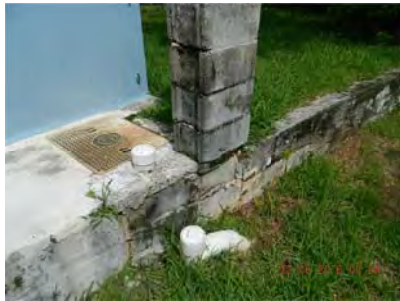
Cesspit clean out and vent. Drop off step may be a safety hazard.

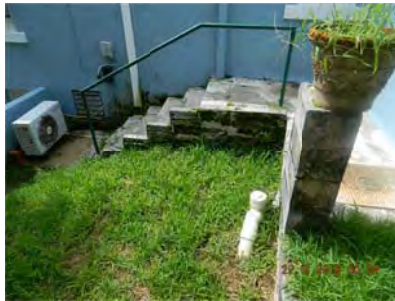
Stair railing is functional but not code compliant

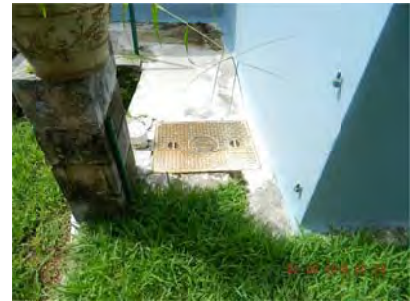
Clean out access lid

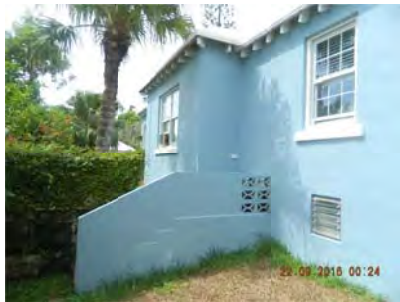
Wall finishes appear satisfactory

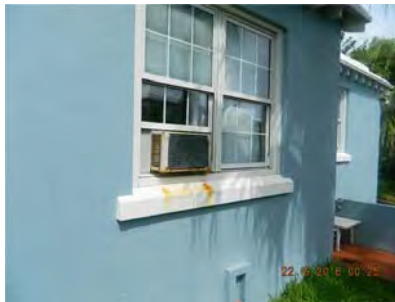
Window AC is causing significant condensation and mold staining.

Rust staining from window AC

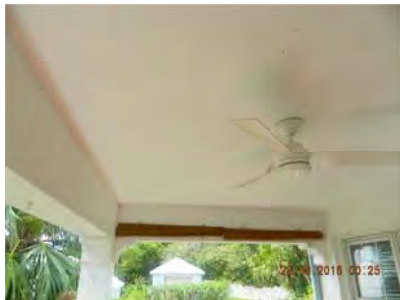
Porch ceiling is satisfactory

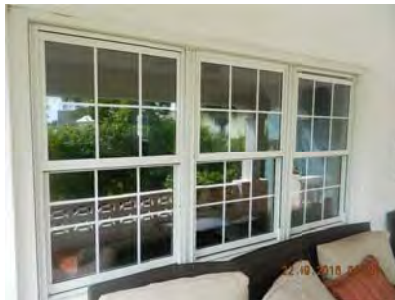
Aluminium windows are functional but need adjustment

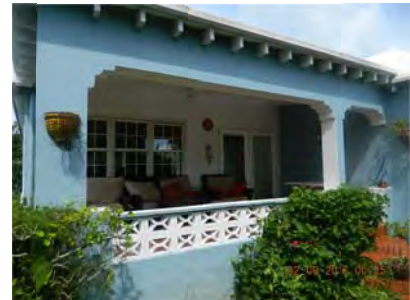
Porch beams and columns appear satisfactory

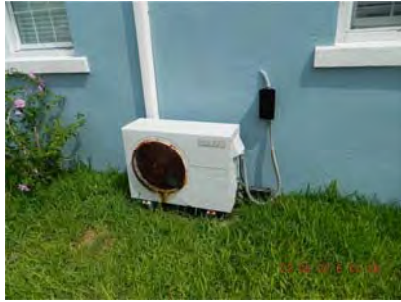
AC unit not tested but shows some corrosion

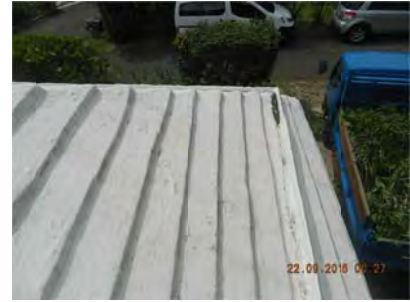
Roof shows some flaking and spalling. Some debris accumulation in gutter glides.

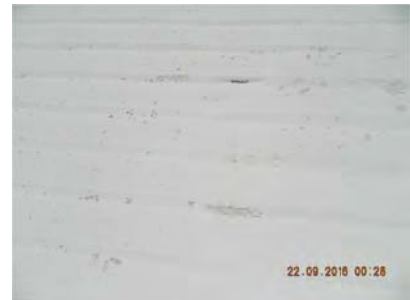
Flaking and general deterioration of roof coating(s)

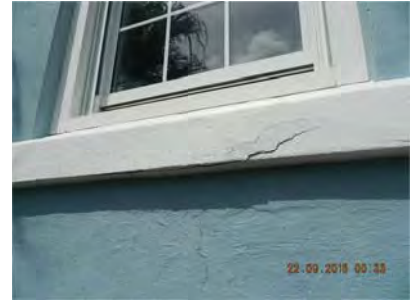
Possible rebar spalling at window brow

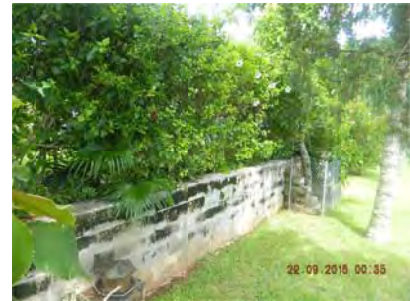
South border retaining wall appears satisfactory

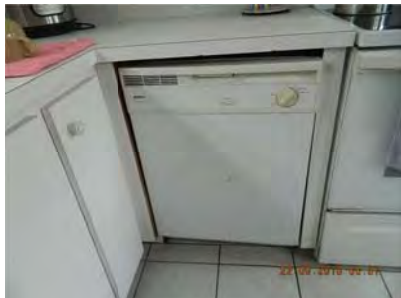
Appliance appears to be loose and needs to be correctly positioned within cabinets. Dishwasher appears aged and may benefit from replacement with new.

Dishwasher needs repositioning and securing to cabinets/countertop

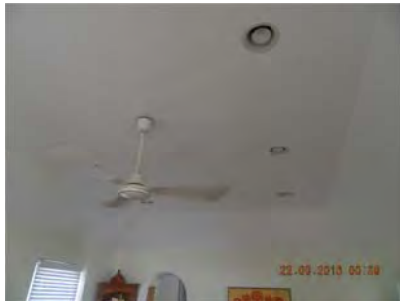
Living room ceiling appears satisfactory

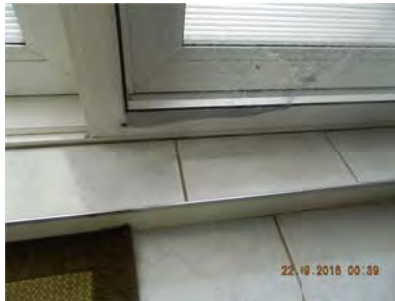
South door screen needs repair

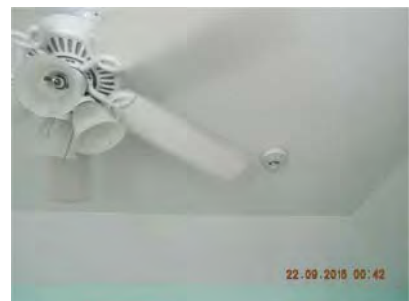
Smoke detectors disconnected.

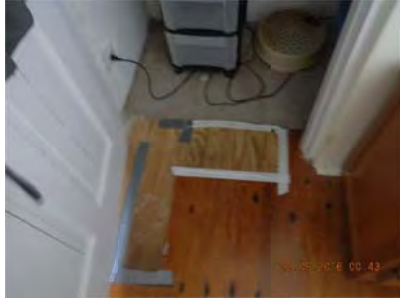
Some repair patches noted. Floors should be sanded to match. Tiled flooring appears satisfactory.

Floor repair needs finishing

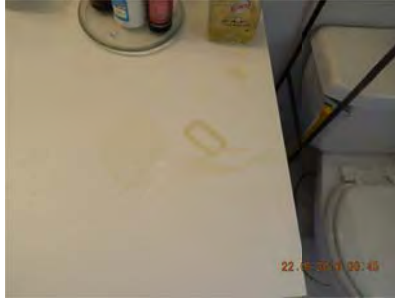
Bathroom vanity top staining

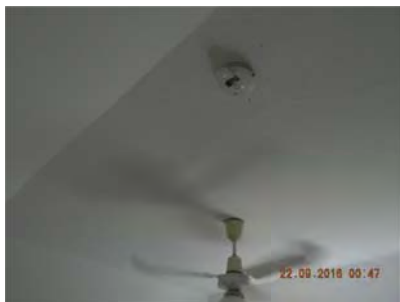
Smoke detector disconnected

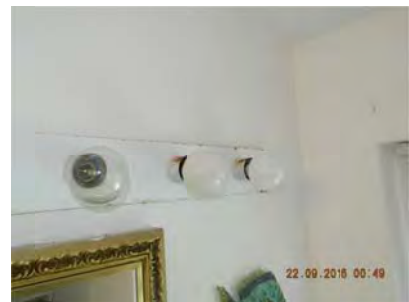
Light fixture shows some rust

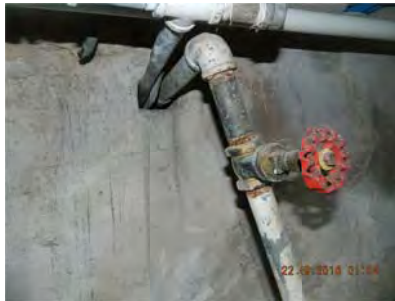
Older galvanized pressure lines and valves

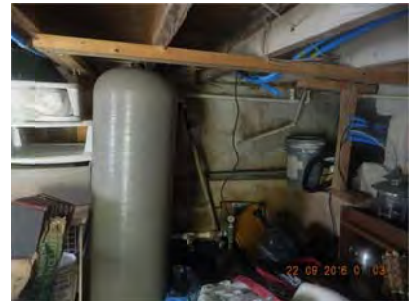
Pre-pressurized tank is functional and satisfactory

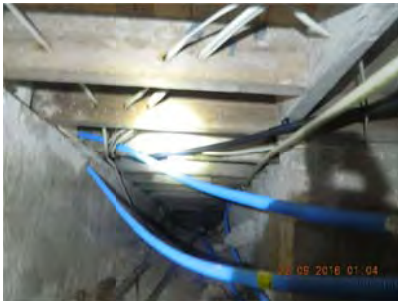
Floor joists viewed in cellar appear satisfactory

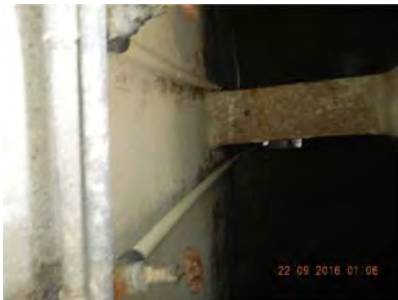
Tank view looking down at divide walls.

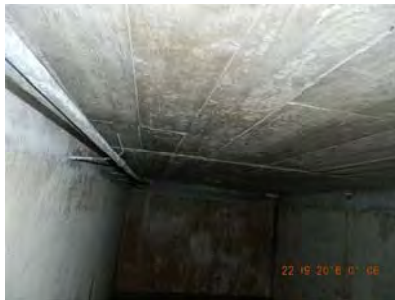
Tank view looking east. Note galvanized suction line
