Structural Survey Report

Sample Report
Devonshire

Mason and Associates Ltd.
July 25th, 2017

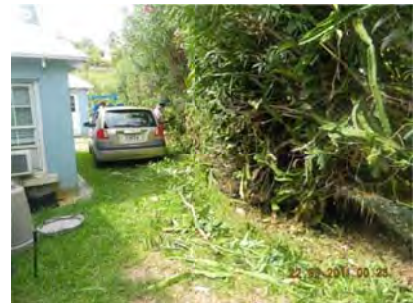
Crews were in the process of tree trimming during the inspection.

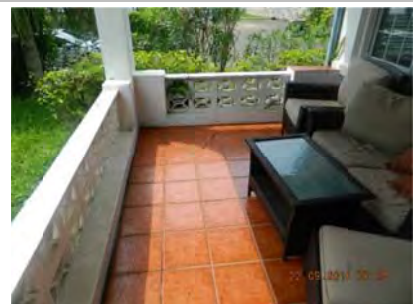
Deck / Porch

No issues

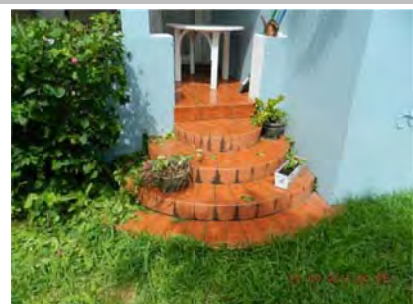
Steps to Building

No issues. Grout lines need cleaning.

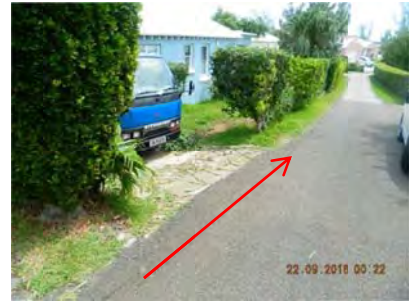
Storm water runoff from the road continues past the property. Ensure a berm protects against drainage running onto the property.

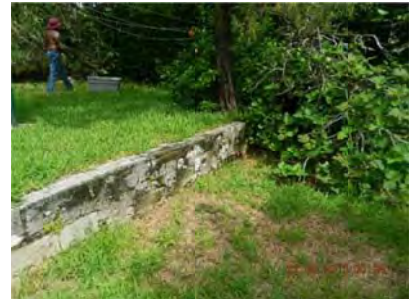
Retaining Walls

No significant issues.

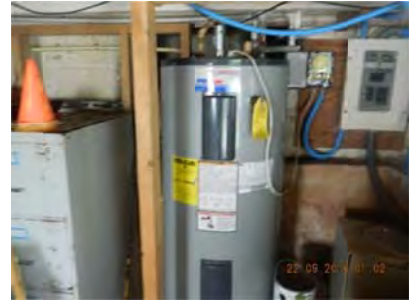
Water heater appears new and functional.

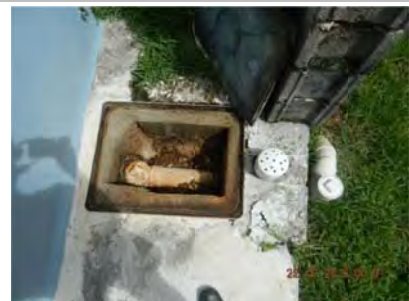
Clean outs and access chambers with exposed PVC piping. No obvious issues related to smells or cesspit slab settlements noted.

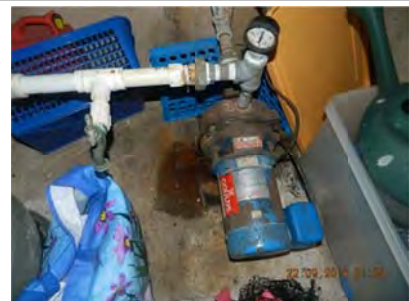
Pump and Pressure Tank

Functional.

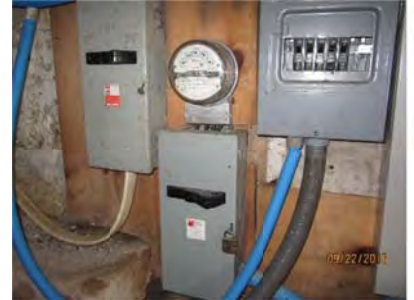
1 Service Entrance (Belco Meter)

The residence is supplied by a single 100A 120/240V single-phase metered service located within the basement east side of dwelling. Appears generally sound.

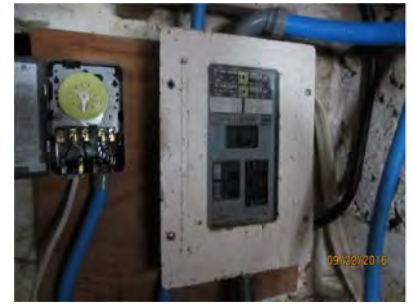
2 Main Panel

A 12 CCT 120/240V electrical distribution panel is located within the basement of the residence.

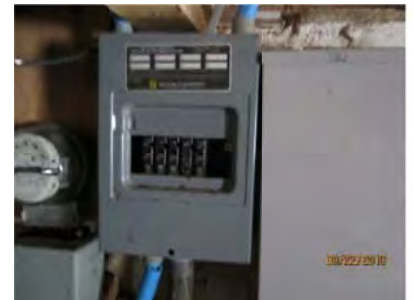
3 Sub Panel(s)

A 8 CCT 120/240V electrical distribution panel is located within the basement of the residence.

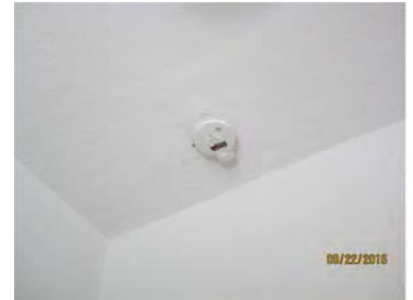
Smoke Detectors

Smoke detectors are installed in all bedrooms and appeared generally sound. Tested ok on line voltage but not on standby battery power as batteries have been removed leaving occupants at risk in the event of a power outage.

Replace defective outlets, GFCI's and install batteries in smoke detectors

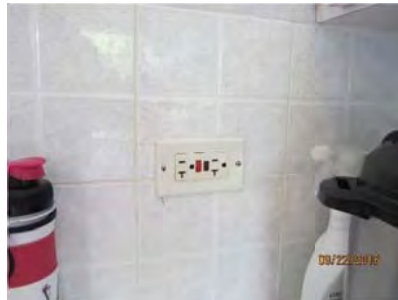
4.5 GFCI west wall tested ok

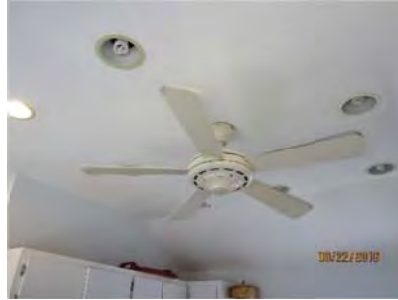
4.8 Fan and fixtures appeared general sound. Exception of some bulbs burnt out. Fan operation was wobbly.

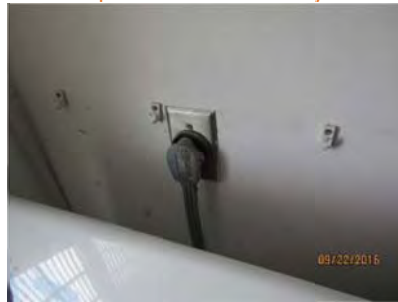
4.11 Dryer and receptacle outlet appeared generally sound.

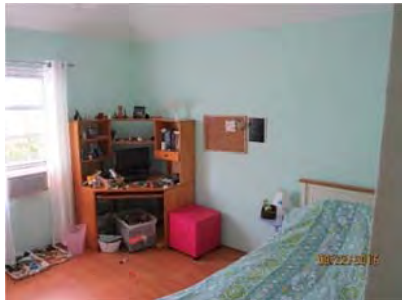
4.28 South Bedroom fixtures switches and outlets appeared generally sound

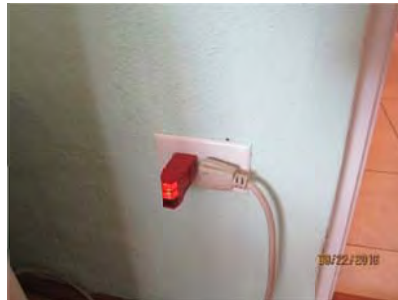
4.29 Receptacle outlet appeared generally sound.

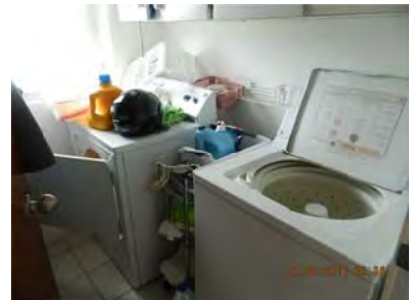
No significant issues.

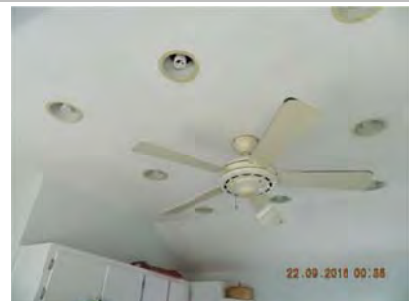
No issues related to water staining or sagging noted.

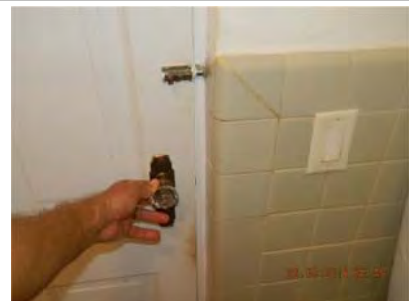
Functional

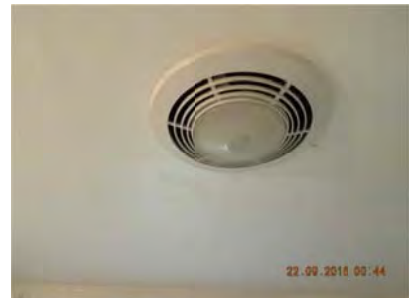
Functional

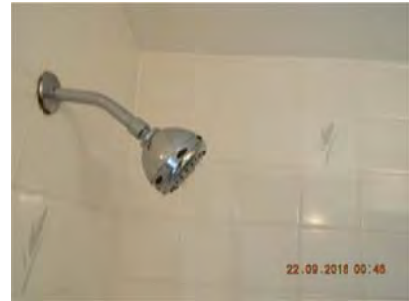
No significant issues beyond some discoloration at base levels.

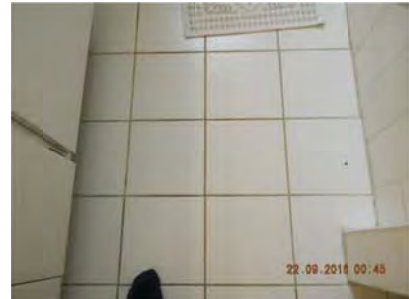
No issues

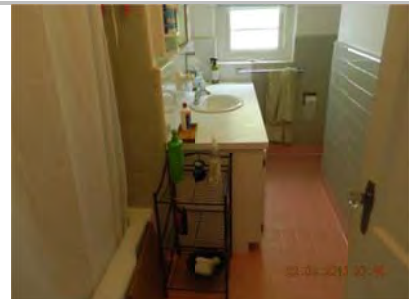
Bathroom is functional but shows some obsolescence with fixtures and finishes and would benefit from upgrading to new.

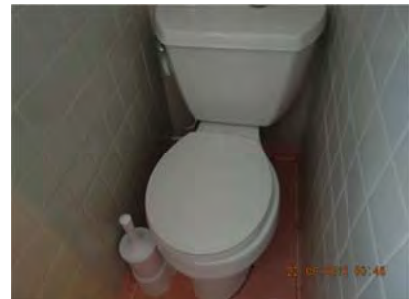
Flush and fill tested Ok

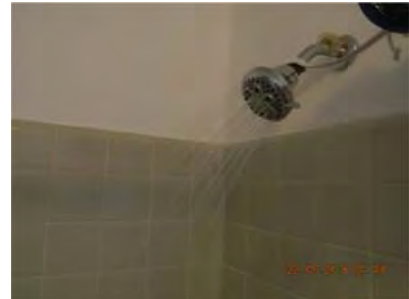
Functional but show some obsolescence

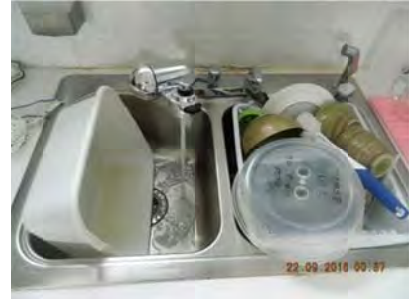
No obvious issues.

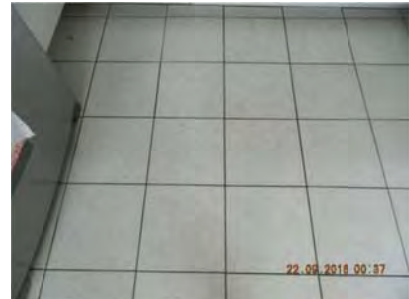
No issues

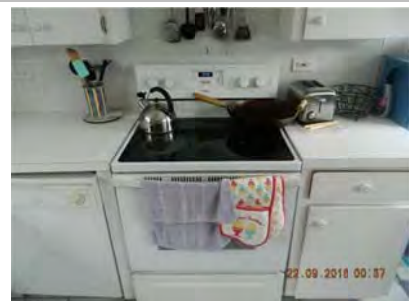
Functional

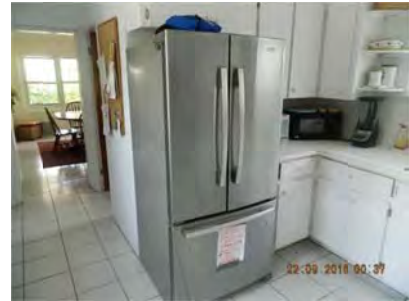
No issues

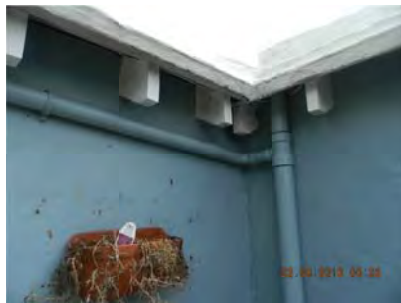
Rain water piping and positioning of downspouts is odd but appears functional. Monitor

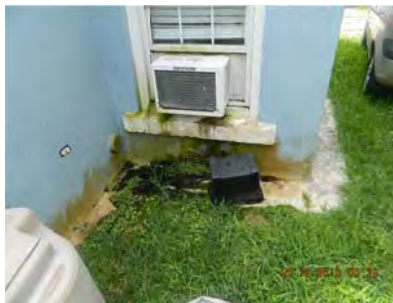
Window AC is causing significant condensation and mold staining.

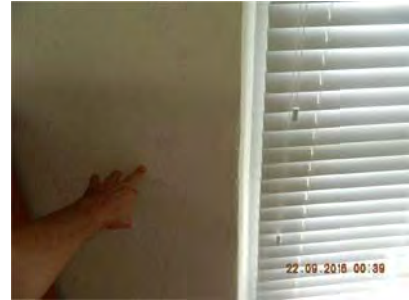
Some efflorescence and moisture damage noted at the dining room beam and walls near windows. This coincides with the exterior RWP and earlier comment to repair.

Wall efflorescence

Dining room walls show some paint finish deterioration. Debonded exterior plaster may need to be hacked off back to base masonry and replaced with a Xypex infused plaster finish, primed and painted after correct curing.

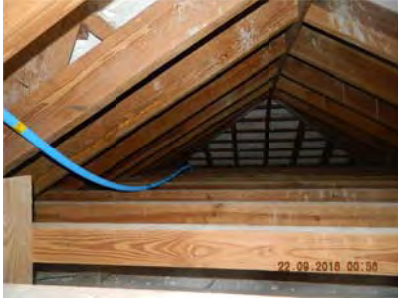
Insect detritus accumulation

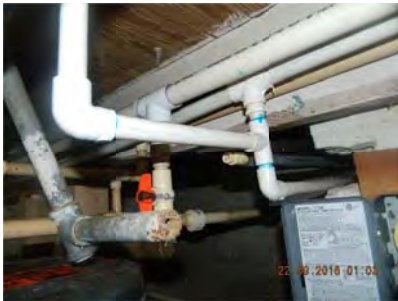
Newer PVC pressure lines

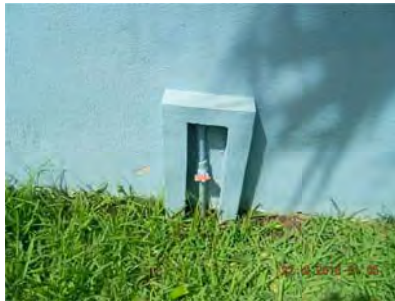
Unknown valve. Consult owners
